Manhole Inspection Summary

Manhole # S31K__016MH

Insp Date: **11/23/08 11:17 AM**

Location Address: **Warner St**

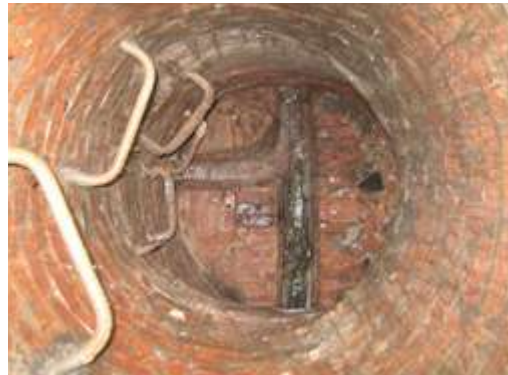
Top View

Note missing rung (3rd from top)

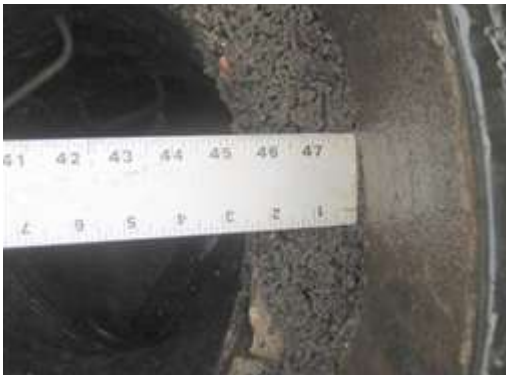
Defect 1

Offset: **2.** (in.)
75

Frame Offset 2.75

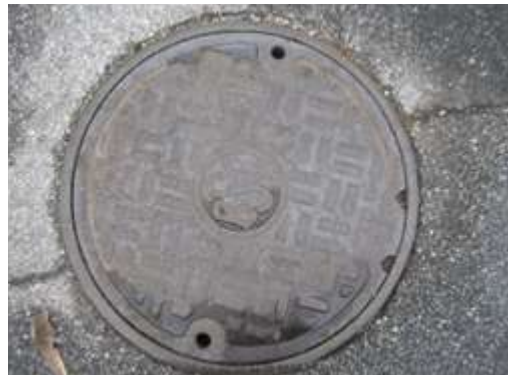
Misc

cover

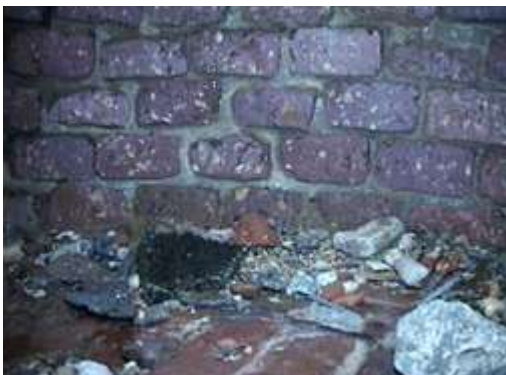
Miscellaneous

bench debris

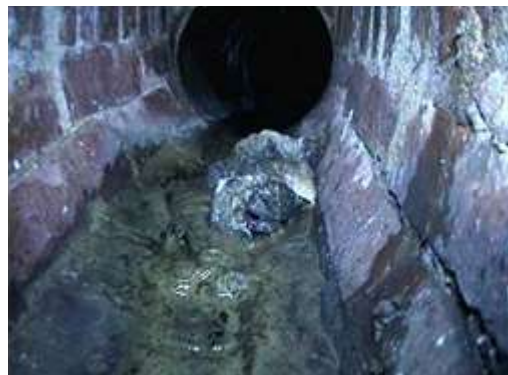
Miscellaneous

channel debris

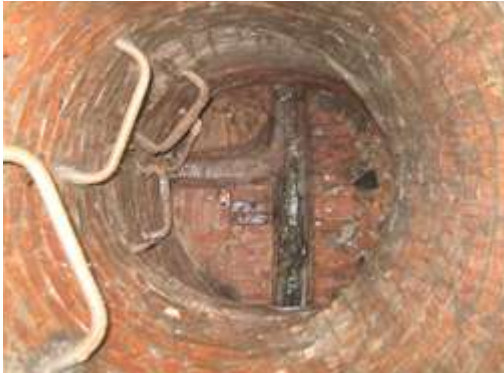
Defect 6

Count: **6** Missing: **1** ☒ **Corroded**

Note missing rung (3rd from top)

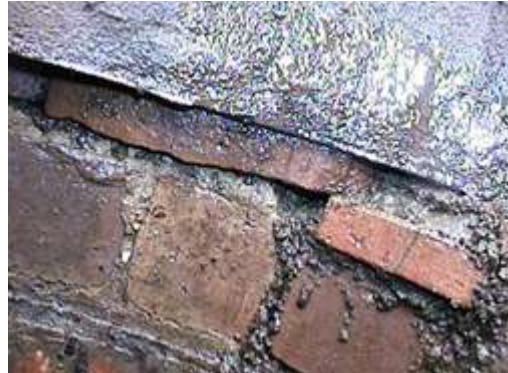
Defect 5

Condition: ☐ Sound ☐ Cracked ☒ **Leaks**

Infiltration: ☐ None ☐ Joint ☐ Cracks ☒ **Mortar** ☐ Roots ☒ **Wall**

frame infiltration at lid, chimney mortar infiltration

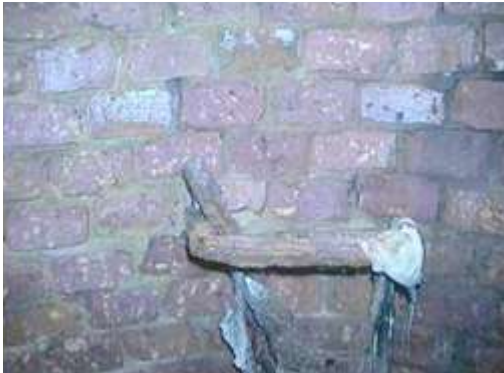
Defect 4

step corroded and debris on step
